# Defect schedule

| PROJECT | Marina Court - Demonstration project |
| PROPERTY | Apartment B-12 |
| INSPECTION | 27 August 2026 |

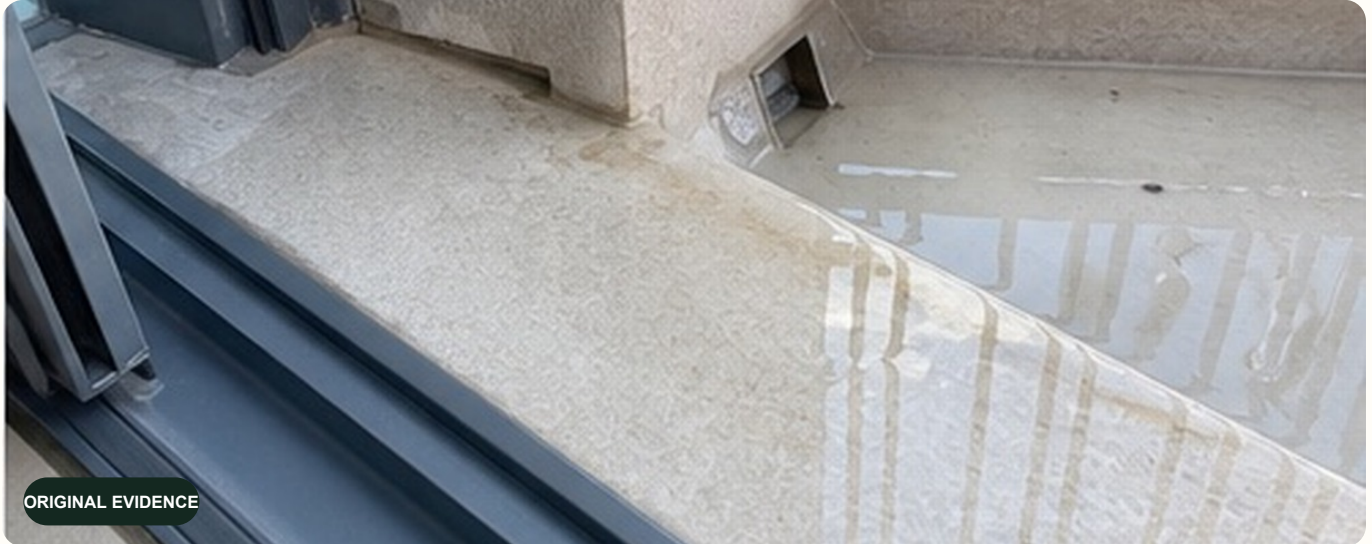
MCT-B12-001

**Standing water remains beside the balcony threshold after the drainage test.**

Μετά τη δοκιμή αποστράγγισης παραμένουν στάσιμα νερά δίπλα στο κατώφλι του μπαλκονιού.

**Confirm the finished falls and clear or correct the outlet before handover. Submit completion evidence for reinspection.**

Να επιβεβαιωθούν οι τελικές κλίσεις και να καθαριστεί ή να διορθωθεί η έξοδος πριν από την παράδοση. Να υποβληθεί φωτογραφική τεκμηρίωση για επανέλεγχο.

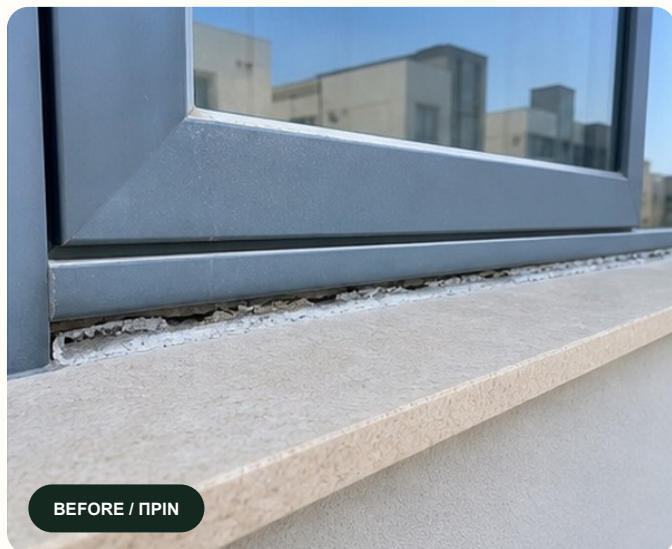
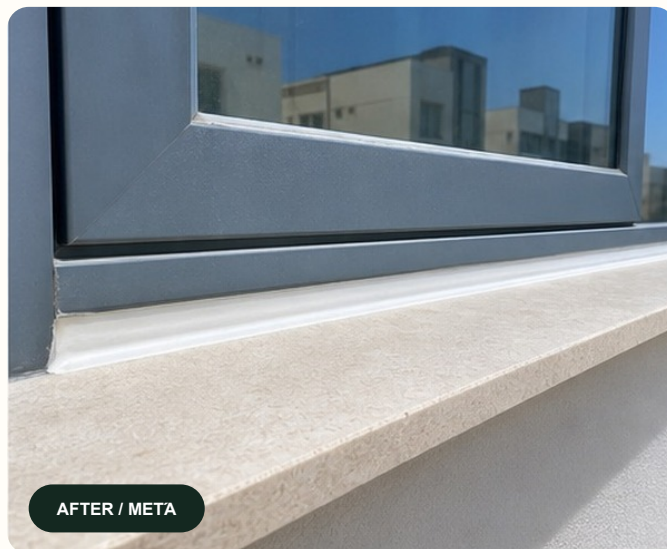
**External sealant was incomplete along the lower edge of the living-room window frame.**

Η εξωτερική σφράγιση ήταν ελλιπής κατά μήκος της κάτω πλευράς του πλαισίου του παραθύρου στο καθιστικό.

**Apply a continuous external-grade sealant bead. The completed work was visually verified during reinspection.**

Να εφαρμοστεί συνεχής εξωτερική σφράγιση. Η ολοκληρωμένη εργασία επιβεβαιώθηκε οπτικά κατά τον επανέλεγχο.

- 27 Aug 2026 Initial inspection completed - four observations issued.
- 29 Aug 2026 Completion photograph received for MCT-B12-002.
- 30 Aug 2026 MCT-B12-002 visually verified fixed; three observations remain open.

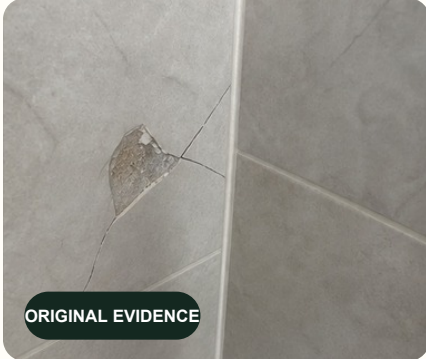
## MCT-B12-003 - FINISHES

**The wall tile is cracked at the lower corner beside the shower enclosure.**

Παρατηρείται ρωγμή στο πλακίδιο τοίχου, στην κάτω γωνία δίπλα στην καμπίνα ντους.

Replace the damaged tile, inspect the substrate and reinstate grout and sealant to match the surrounding finish.

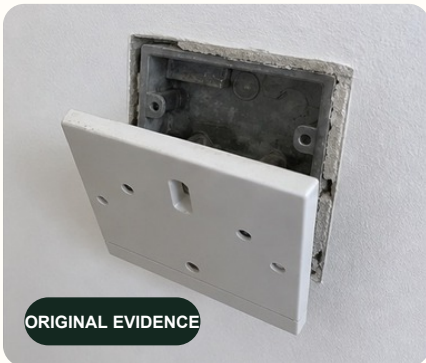
## MCT-B12-004 - ELECTRICAL

**The twin socket faceplate is loose and the back box is visible.**

Η πρόσοψη της διπλής πρίζας είναι χαλαρή και το κουτί εγκατάστασης είναι ορατό.

A qualified electrician must isolate the circuit, secure the socket and confirm safe installation before energisation.
